Inspectors gather for annual seminar

More than 100 LAA inspectors meet for an update on issues and to discuss a range of technical matters cropping up in the field

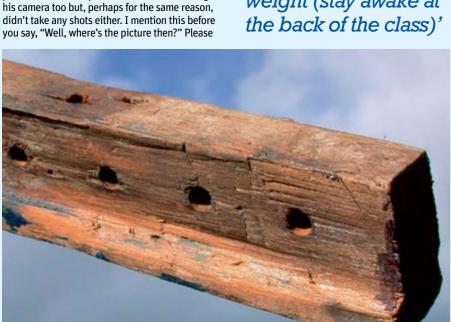
This longeron, from a de Havilland Rapide, has reduced in size from 1 in to 3/4 in. As a lower longeron, at the rear corner of a sloping cabin floor, it was subject to a lot of water soakage. Each time the wood got wet it expanded, crushing the fibres. When the wood dried the attachments became loose and engineers tightened them. In effect the wood ratcheted down to a smaller size.

Next up was Mark Miller, the Chief Engineer of De Havilland Support, who gave a brilliant lecture on inspecting old wooden types. Mark spent some time explaining the problems of determining the acceptability of old wood, especially after accident damage. Check out the excellent picture of a longeron that had to be changed on his Rapide.

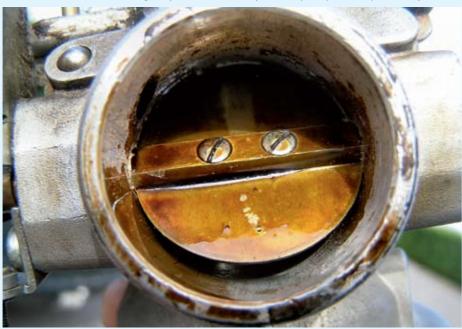
Alan's flying partner, David Walsh, was on a trip to Southern France in his MCR-01 and dropped in to Montpassat, which, so Allan informs me, is France's largest ULM base. He noticed the throttle 'didn't quite feel right', then it started sticking. Subsequent investigations revealed a brownish deposit inside the carburettor – take a look at the photographs.

analysis confirmed this. It looks like something in the fuel reacted with this sloshing compound. It

In some mysterious way, perhaps a strange combination of temperatures and pressure, the fuel changed its chemistry and attacked the fuel tank. This brown deposit was later analysed and found to be fuel tank sealant. It's not just the engine that needs to be assessed for Mogas suitability.

hadn't happened before on this aircraft and, so far, it hasn't happened since. All I can say about this is. keep a close eye on your fuel system components.

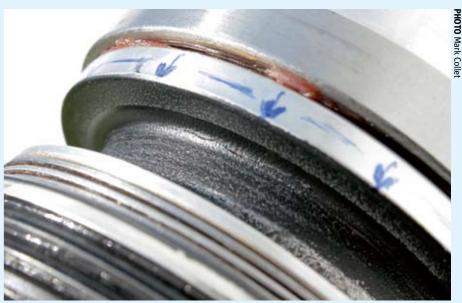
The AP332 design uses an electrically driven pitch change mechanism married to a Warp Drive blade. The blade itself is secured using a ferrule which is, in effect, a four-piece clamp. This clamp acts as a bearing surface which permits free rotation of the blade around it's axis and secures the blade into the hub. Cracks have been found between the bearing surface and the clamping portion of the ferrule.

Airmaster produced a factory bulletin requiring an increase in the check frequency to each 50 hours last year but this crack was not found during one of these checks. It was noted by the pilot, LAA member Bob Knapton, as "an increase in vibration and a general feeling all was not well. The vibration went away with a small reduction in manifold pressure".

I'm not sure exactly what's going on here, and couldn't know without sectioning the crack and conducting a full analysis, but it's looking like a fairly straightforward case of fatigue failure.

Whether the fatigue is being caused by high stress within the clamp during assembly (ie preload) or unusual harmonics focussing stress into a particular section of the ferrule, we may never

Fatigue cracks like this mean that the load passing through the component are no longer supported by the material. This forces the load to find a new path which will, almost certainly, place other material in an overload situation.

One saving grace, with this particular design, is that it is readily inspectable. The LAA will be decreasing the time between inspections and decreasing the ferrule life.
