SERVICE BULLETIN: JSB 042-1

Release Date: 16th May 2019

Subject: Jabiru Aileron control tube

Affected Models: All aircraft

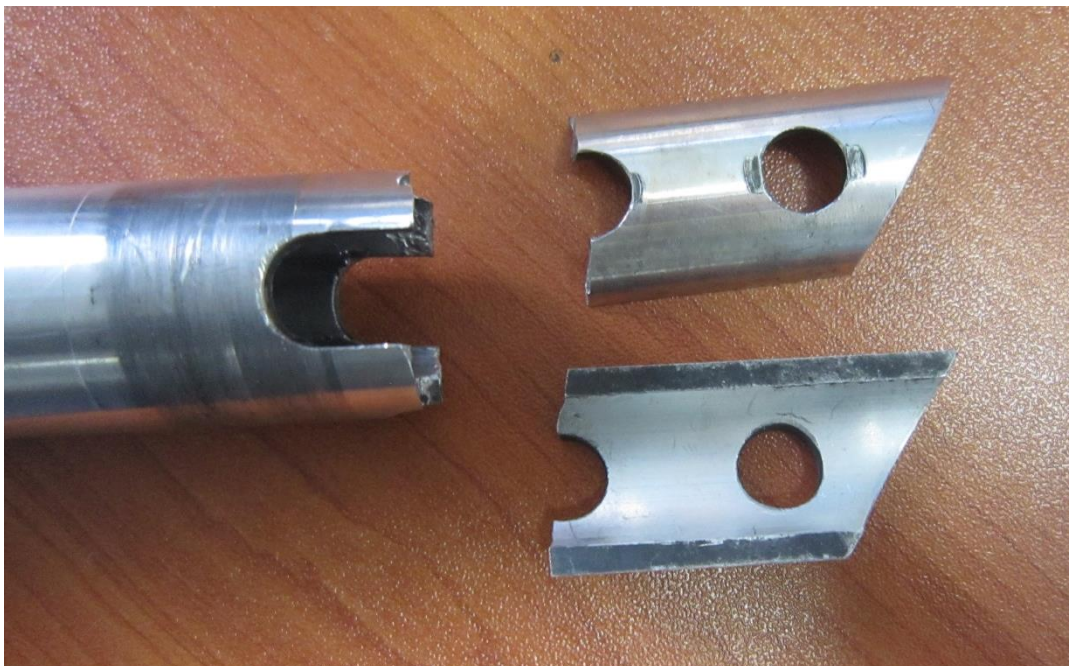
- A failure of the aileron control tube over 8500 hours TTIS was brought to the attention of Jabiru Aircraft whereby the aileron control tube failed in fatigue at the second control stick attachment bolt. With no connection, aileron and elevator control could have been lost. Figure 2 shows the failed aileron control tube, showing where the failure occurred.

Figure 2: Failed tube.

If any sign of cracking is found confirmation and corrective action must be taken before any further flight. Contact Jabiru Aircraft if this situation is encountered and complete a Continued

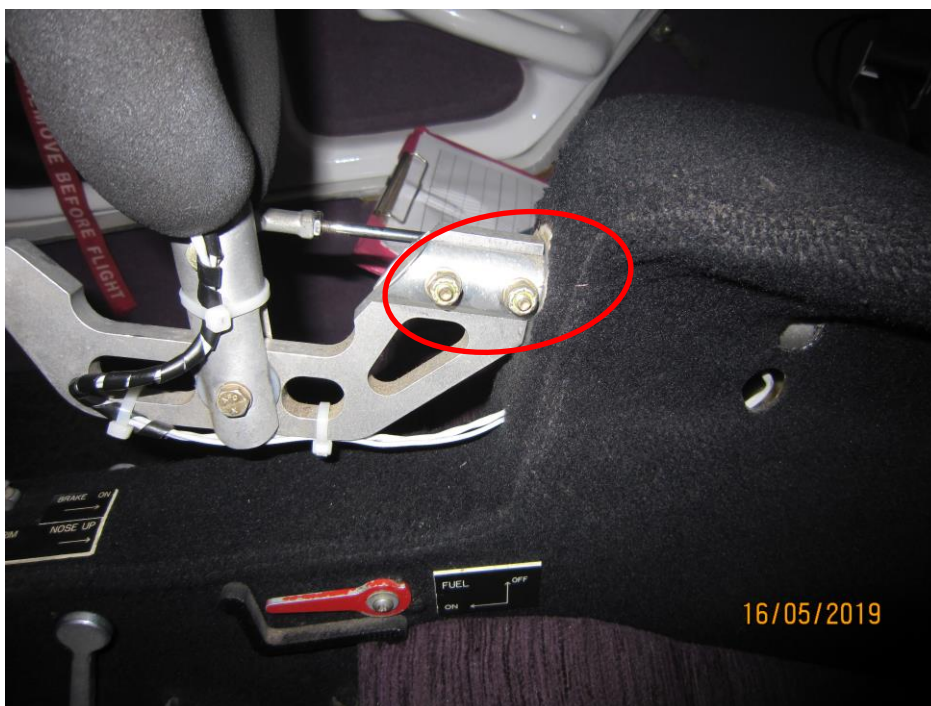
Figure 3 – Location of tube to inspect

- 1) Clean the surface of the tube around the second control stick attachment bolt. Use a cloth moistened with water or a hydrocarbon based cleaner. Don't use anything that might be corrosive to aluminium.

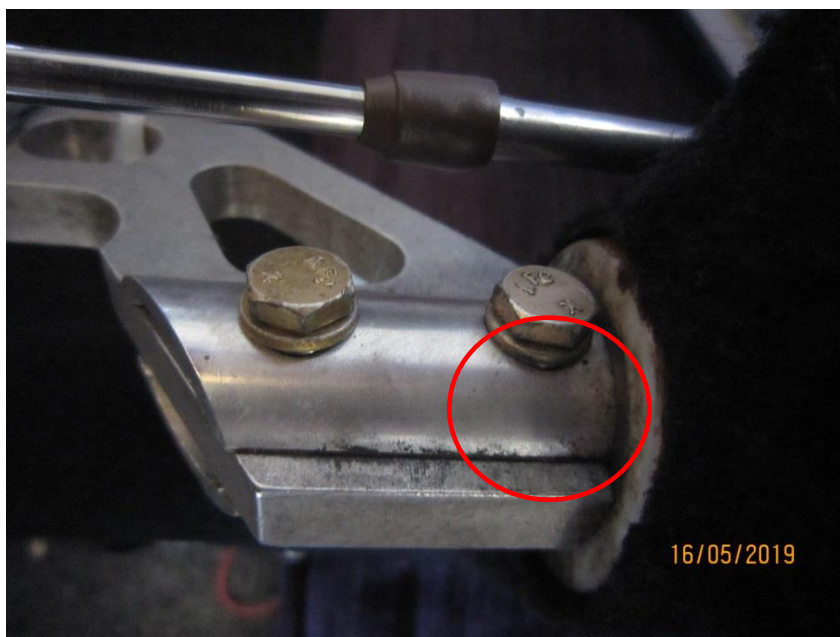
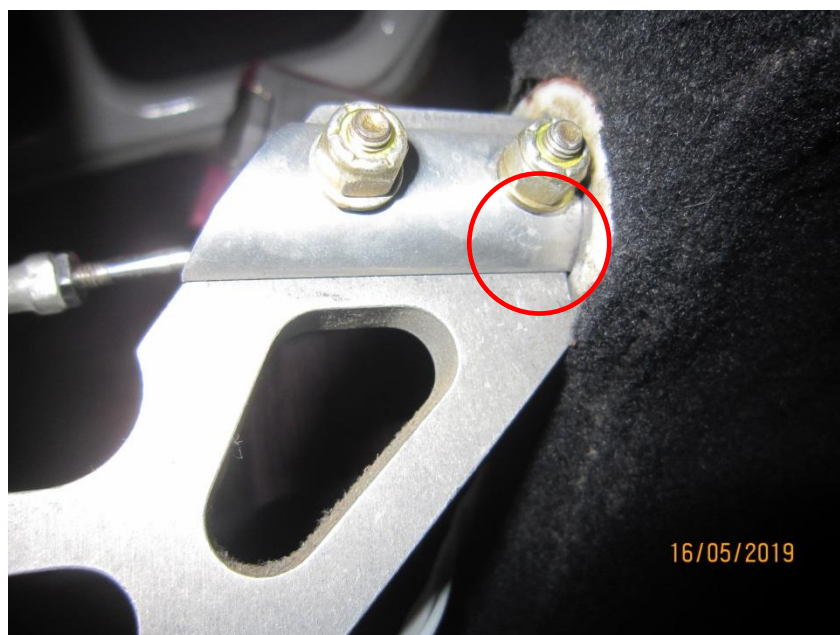
Figure 4 – Top side of control tube.

- 2) Inspect the four quadrants, with a bright light, for signs of cracking. For the lower quadrant, the control stick will need to be turned to its aileron limit in each direction, to enable proper visibility. Analysis of the failed part showed that one quadrant had been cracked through for some time before complete failure occurred.
- 3) Lightly apply a force on the control stick away from the quadrant being inspected.
- 4) Repeat steps 2 and 3 until all 4 quadrants have been inspected.
