AEROPRAKT
INFORMATION BULLETIN
REPLACEMENT OF THE FUSELAGE STRUT ATTACHMENT
FITTINGS OF A-22 AIRCRAFT
IB A-22-05

MANDATORY

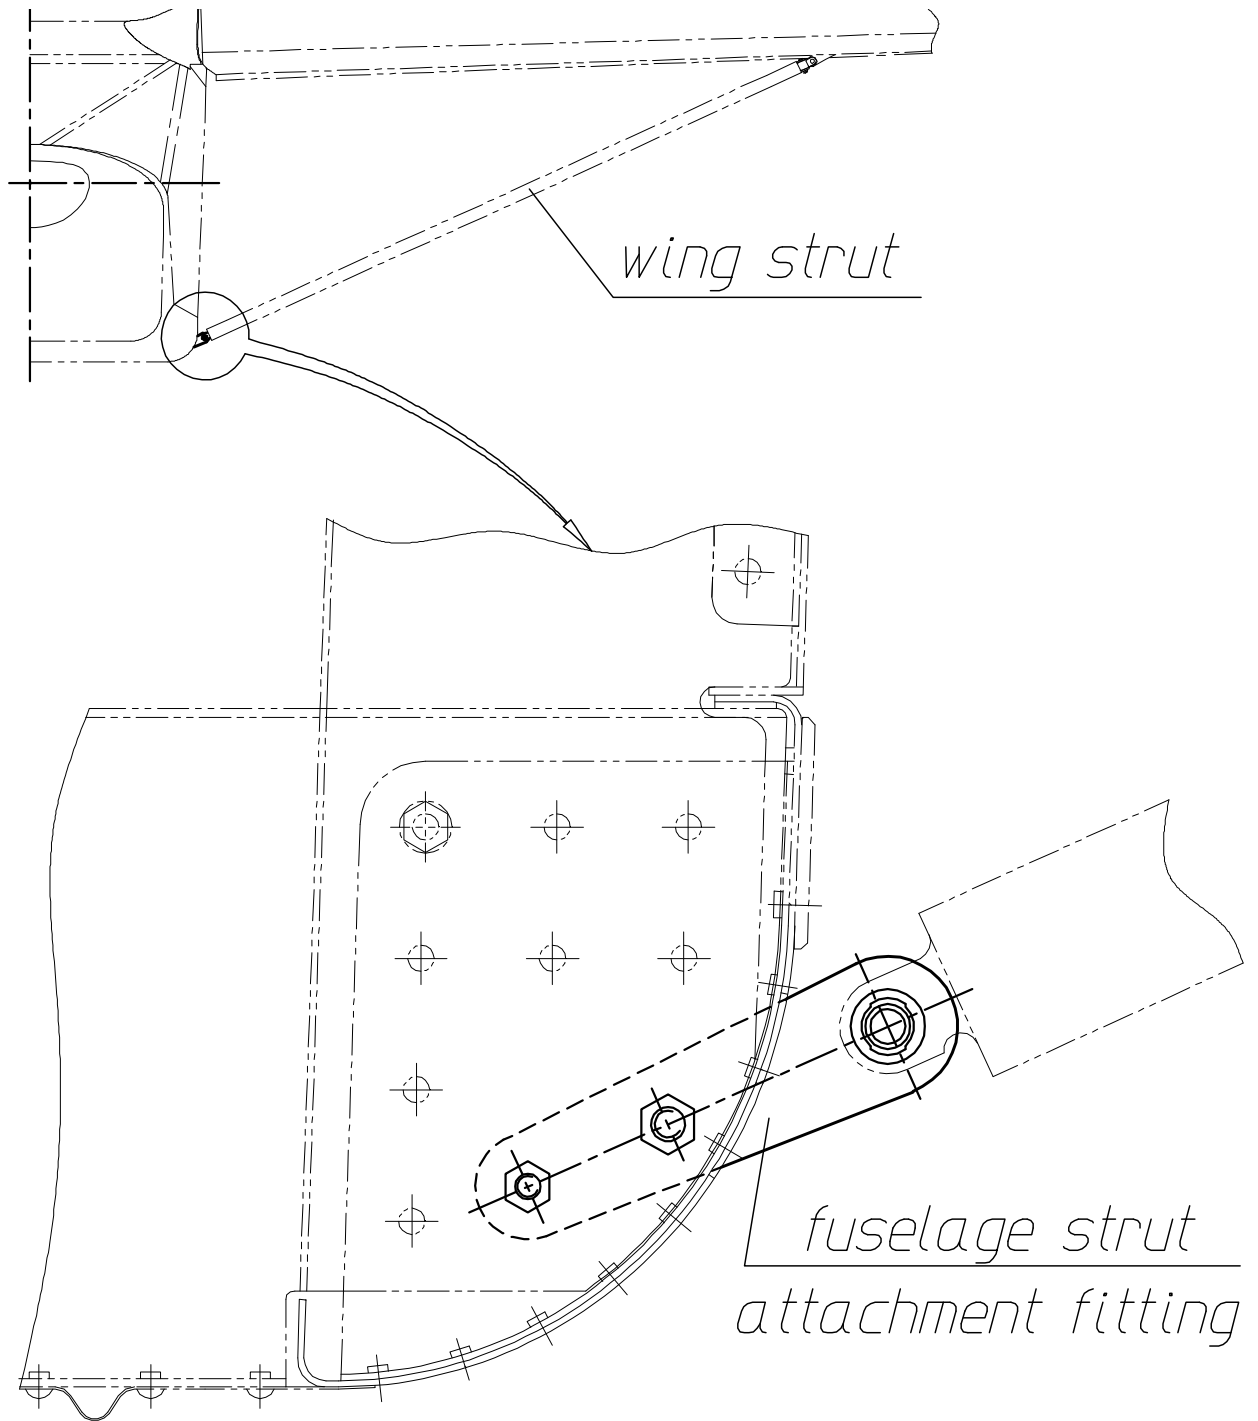
Fig. 1

The reason of the replacement of the strut attachment fittings is expired fatigue life.

- 1) Remove the right and left wing, right and left wing struts.
- 2) Remove the fuselage strut attachment fittings (fig. 1) and send to Aeroprakt.

- 1) Install the new strut attachment fittings to the same holes using old bolt (install bolts with primer) but new self-locking nuts.
- 2) Install the struts and wings.
