AEROPRAKT SERVICE BULLETIN

№ SB A22LS-20

CHECK OF A-22, A-22L, A-22LS AND A-22L2 AIRCRAFT HARNESS SYSTEM ELEMENTS FOR CORRECTNESS OF INSTALLATION

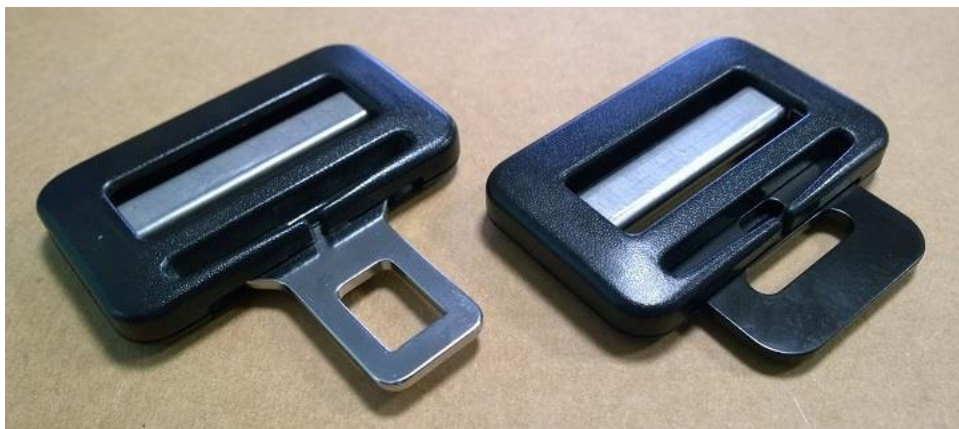
Photo 1

Serial number(s) affected: All aircraft with harness system buckles as shown on photo 1

Aeroprakt-22, Aeroprakt-22L, Aeroprakt-22LS and Aeroprakt-22L2 aircraft that have harness system with buckles as shown on photo 1

Incorrect placement of the buckles of the harness system.

Inspection and check of the harness system for correct installation and, if necessary, elimination of non-compliance.

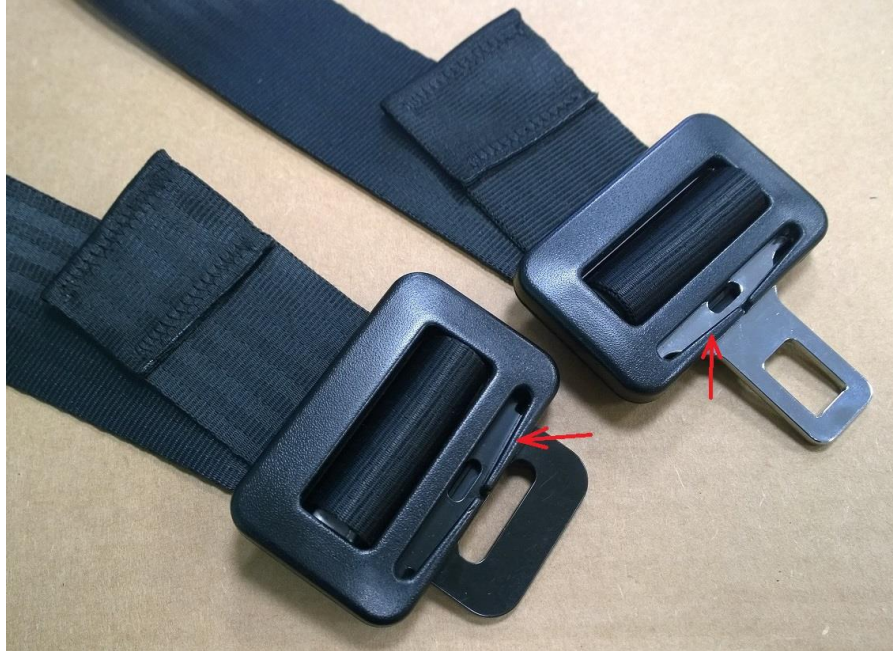
Photo 2

3.1) Check the harness belts for correct position with regard to the buckles. The correct position of the belt is shown on photo 2. Incorrect position of the belt is shown on photo 3.

▲ The specific element of the buckle marked with arrows on photo 2 must be always directed away from pilot's body when the harness system is fastened.
