SERVICE BULLETIN: JSB 042-1

Release Date: 16th May 2019

Subject: Jabiru Aileron control tube

Affected Models: All aircraft

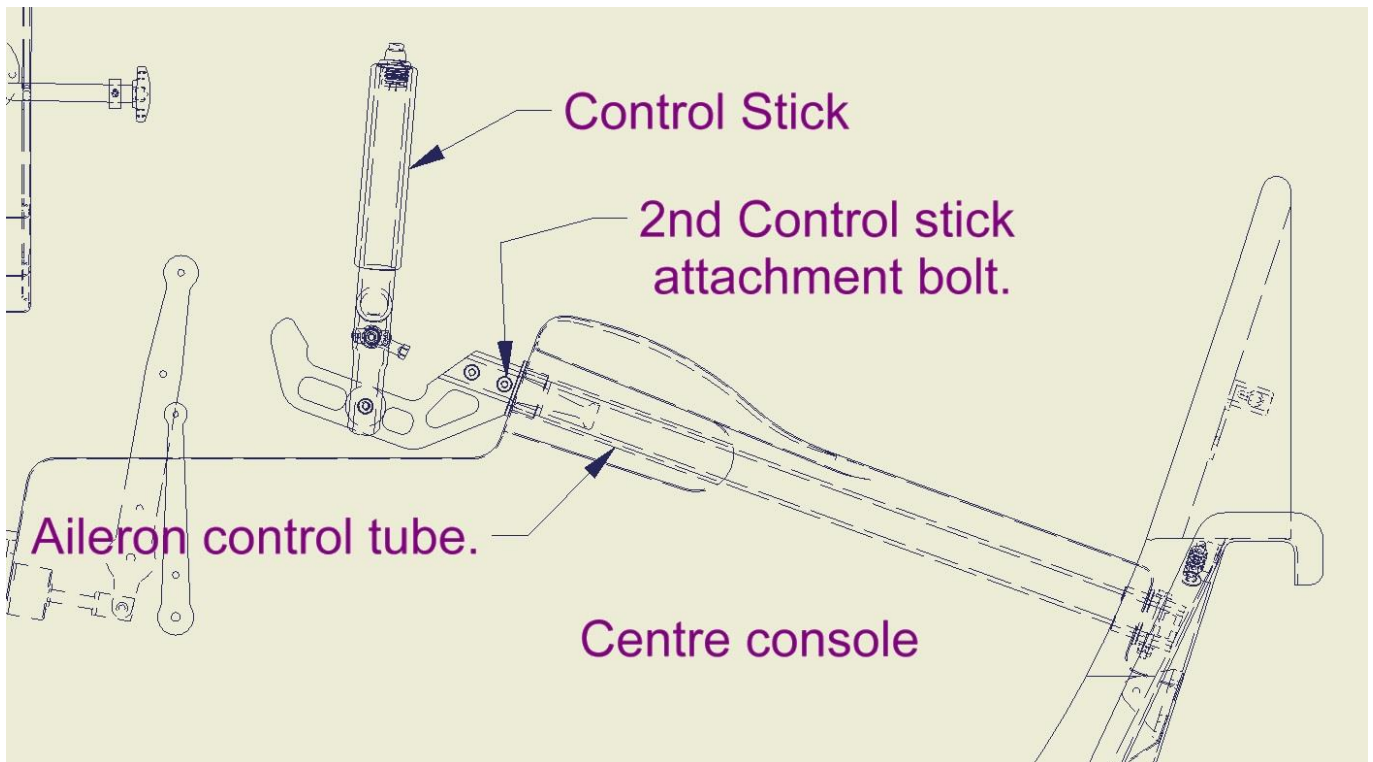
Figure 1 – Elevator cable layout example

- The Jabiru Aileron Control Tube is a machined aluminium tube that runs from the control stick assembly through the centre console to the aileron cable bell-crank. Refer to Figure 1 for correct terminology.
