SERVICE BULLETIN

Periodic inspection of the float buoyancy for ROTAX® Engine Type 912 and 914 (Series)

ATA System: 73-00-00 Fuel system

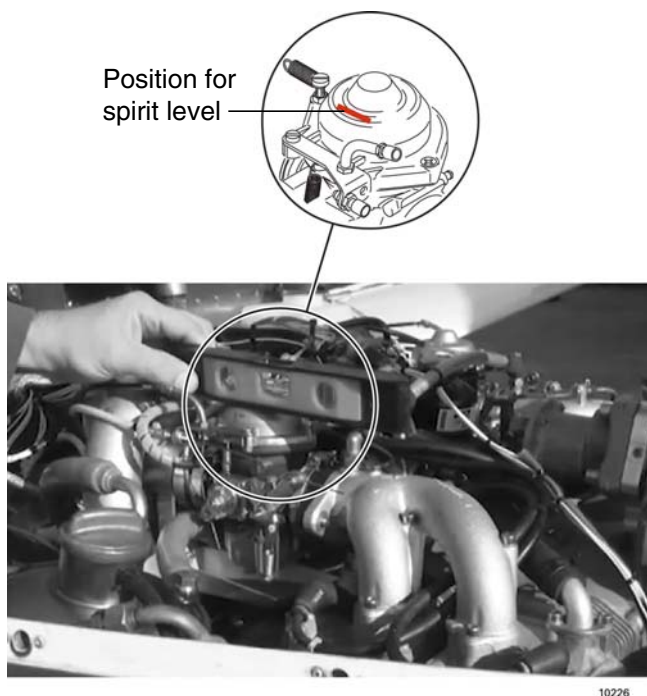
Fig. 1

Step	Procedure
1	Bring the float chamber to horizontal position (level the aircraft, if necessary and check the horizontal position with a spirit level). See Fig. 1.
2	Engine Series 912: Run the engine at idle for approx. 1-2 minutes without electric fuel pump. Engine Series 914: Run the engine at idle for approx. 1-2 minutes with main fuel pump.
3	Switch off the engine and follow safety notice chap. 3.
4	Remove the return spring (1). See Fig. 2.
5	Remove 4 Philips head screws (2). Remove rotary valve housing (3) with the gasket. See Fig. 2.
6	Remove the air vent line (4). See Fig. 2.

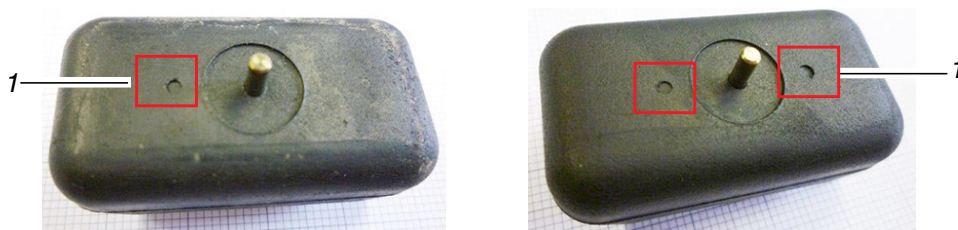
Fig. 5

NOTE: For traceability some floats (new but also already installed) show one or two markers. The imprinting is shown in Fig. 5. These markers have no effect on the function of the floats.

1 Marker

Only floats without weight control markers or according to SB-912-067/ SB-914-048 have to be changed. Already marked floats (see Fig. 1) must not be changed.
